Lake Ramsey Homeowners Association

Entrance update 3-18-2021

Culvert repair:

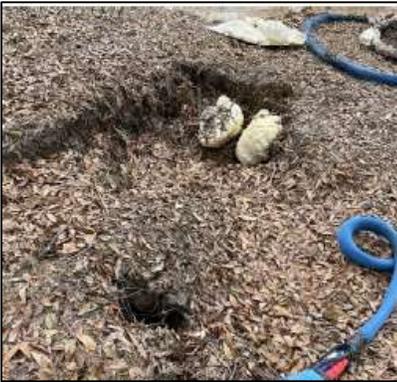
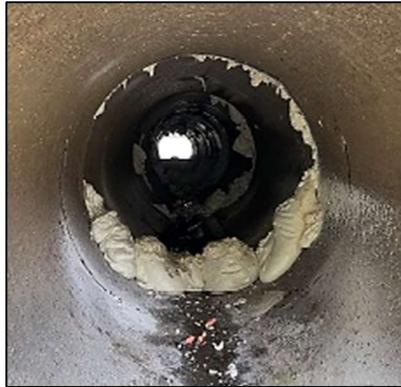
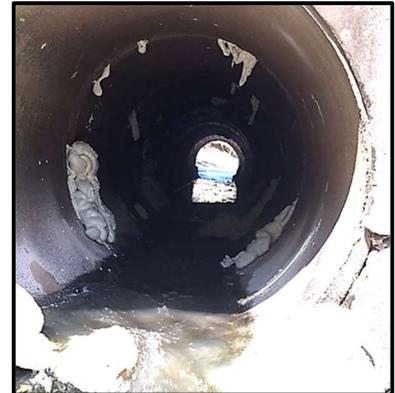
The foam injection work is complete. As expected, there was an extensive void under the culverts. Further, there were more voids above the first two culverts closest to the gate than anticipated. In some areas, the foam injections from within the culverts reached the surface of the ground above the culverts. As a result, an additional 5002.62 pounds of foam was installed in unexpected void areas for an additional cost of \$50,851.59 that the Board will pay for using contingency funds and cost savings wherever possible.

Excess foam has been trimmed and removed. The road repair will begin and includes the area beginning inside the gates to the culverts and oak trees. When the road inside the gates was widened, the underlying road bed was not comparable to the original two-lane road which has resulted in uneven sinking in the widened area close to the gates. This work will require deeper road bed preparation and may also result in additional costs.
