Entrance Updates

Road Entrance Update

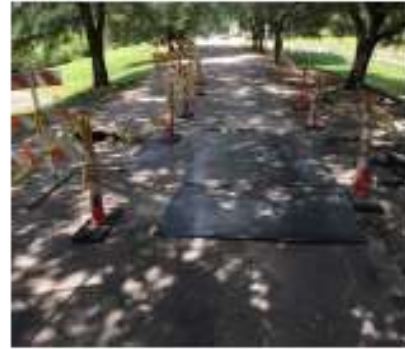
Representatives from STP have suggested that we request to use the single-lane construction road (to the north just outside the red brick gate columns) as a temporary entrance. We investigated this possibility and found the road to be greatly substandard, requiring extensive rebuilding. It also appears that the owner is unwilling to cooperate in granting use by us or to rebuild the road. The front entrance inbound lane is unusable to traffic and is closed off with barricades.

The area of the 5' dia x 30" deep washed out hole in the outbound lane was filled with 4 tons crushed limestone, compacted, and is now covered with the 3 existing 4' x 8' x 1/2" steel plates which were supplemented with 4 more. Two (2) additional steel plates (4' x 8' x 1/2") were added to the center section of the plates totaling 1" thick over the filled hole, one (1) to the length to increase the total length to 16 feet and one to the side over the area leading to the inbound hole to better distribute the weight for trucks with dual rear wheels. All 7 of the plates are welded together. We are allowing all traffic to use the roadway because we have no way to police the traffic and

The area of the 5' dia x 30" deep washed out hole in the outbound lane was filled with 4 tons crushed limestone, compacted, and is now covered with the 3 existing 4' x 8' x 1/2" steel plates which were supplemented with 4 more. Two (2) additional steel plates (4' x 8' x 1/2") were added to the center section of the plates totaling 1" thick over the filled hole, one (1) to the length to increase the total length to 16 feet and one to the side over the area leading to the inbound hole to better distribute the weight for trucks with dual rear wheels. All 7 of the plates are welded together. We are allowing all traffic to use the roadway because we have no way to police the traffic and to refuse entry to heavy loads. There is a sign at the brick columns at the property line instructing some trucks to make a U-turn. We blacked out the portion of the sign that instructed those trucks to use the back emergency entrance on Major Lane. We may rework the sign to more accurately reflect the need to not allow some trucks. At this time, the repaired single lane will serve as the only entrance to our subdivision until the final corrective work commences and is completed.
